# ENGINEERING SUPPORT PROGRAM

EVALUATION OF PUL-E-KHUMRI I & PUL-E-KHUMRI II  
MINI-HYDROELECTRIC POWER PLANTS  
CITY OF PUL-E-KHUMRI,  
NORTHERN AFGHANISTAN

MAY 2, 2010

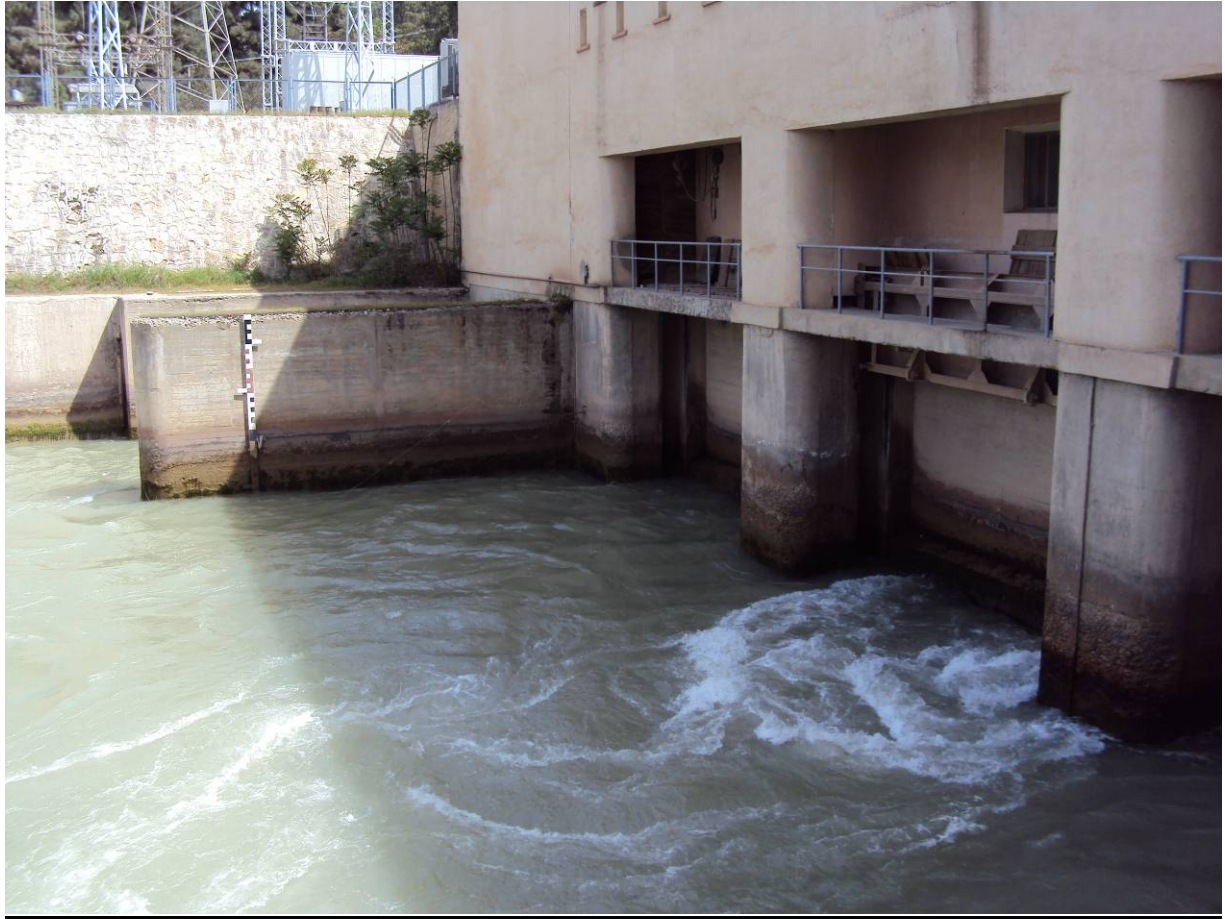
**Staff Gage Affixed to Concrete Wall for Measuring Water Levels at Pul-e-Khumri II Hydroelectric Power Plant Facility (note high water level marks on concrete).**
